NACA RM E53E18

EXPERIMENTAL INVESTIGATION OF AIR-COOLED TURBINE BLADES IN TURBOJET ENGINE XIII - ENDURANCE EVALUATION OF SEVERAL PROTECTIVE COATINGS APPLIED TO TURBINE BLADES OF NONSTRATEGIC STEELS

By Edward R. Bartoo and John L. Clure

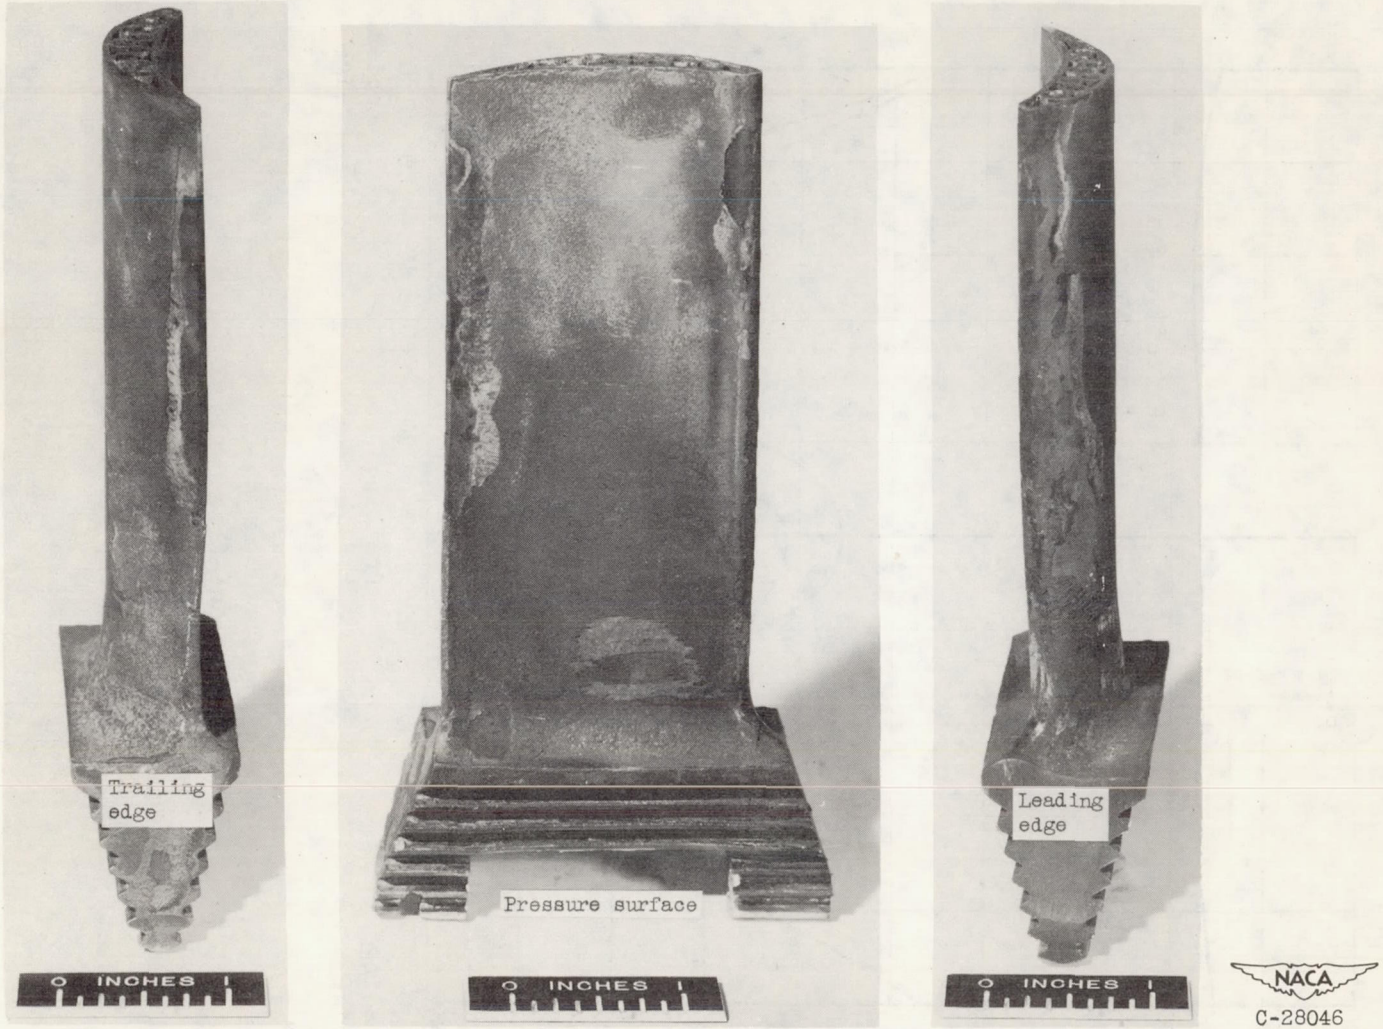
Figure 3. - Typical ceramic-coating failures.

Blade 1. - The coating on blade 1 was considered a failure after 7.3 hours of rated engine speed operation, and investigation of the blade was concluded at the end of that time. Figure 3(a) shows several views of the blade at the conclusion of the tests and it can be seen that the coating chipped away from the leading- and trailing-edge regions of the blade. There is also an area near the root in the midchord region of

the blade where the coating flaked off. The failure of the coating apparently was a function of the metal temperature, as the greatest damage to the coating occurred at the leading- and trailing-edge regions where the metal temperatures are the highest (see fig. 2). More coating was removed from the leading edge than from the trailing edge, probably because the high-velocity combustion gases impinge directly upon the leading edge and their erosive action is greatest in this area.

(a) Blade 1 after 7.3 hours (20 cycles plus 2.3 hours at rated test conditions) with coolant-flow ratio of 0.048. Complete breakdown of coating along leading and trailing edges evident.

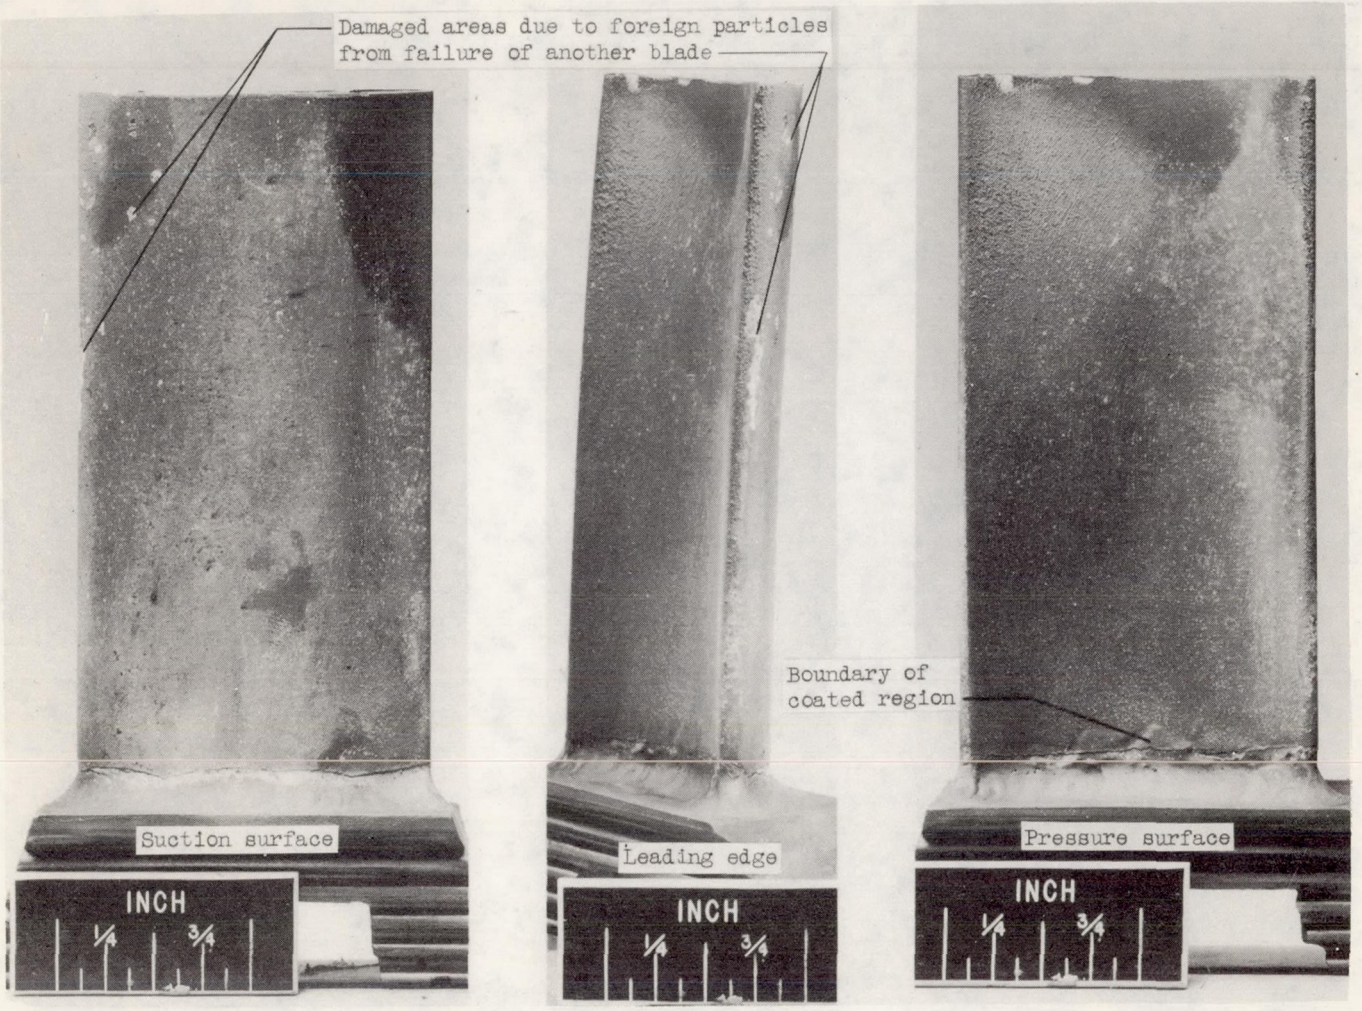
Figure 3. - Concluded. Typical ceramic-coating failures.

Blade 2. - Blade 2 was considered a failure after about 4.7 hours of operation. Inspection at this time indicated that the coating apparently softened when heated and flowed toward the blade tip under the influence of the high centrifugal forces. A photograph of this blade is shown in figure 3(b). The flow lines were essentially parallel to the blade base over the relatively cool midchord region on both the pressure and suction surfaces. In the leading- and trailing-edge regions, which operate hotter than the midchord region, the flow lines were nearly radial and were very pronounced as shown in figure 3(b). Bare metal was visible in the valleys between flow lines in the leading- and trailing-edge areas. Inasmuch as the blade was not heat-treated, there was no possibility of damage from this source, and it must be assumed that the coating lacked the necessary physical properties for the application in question.

(b) Blade 2 after 4.8 hours at rated test conditions with coolant-flow ratio of 0.048. Coating softened and flowed toward tip.

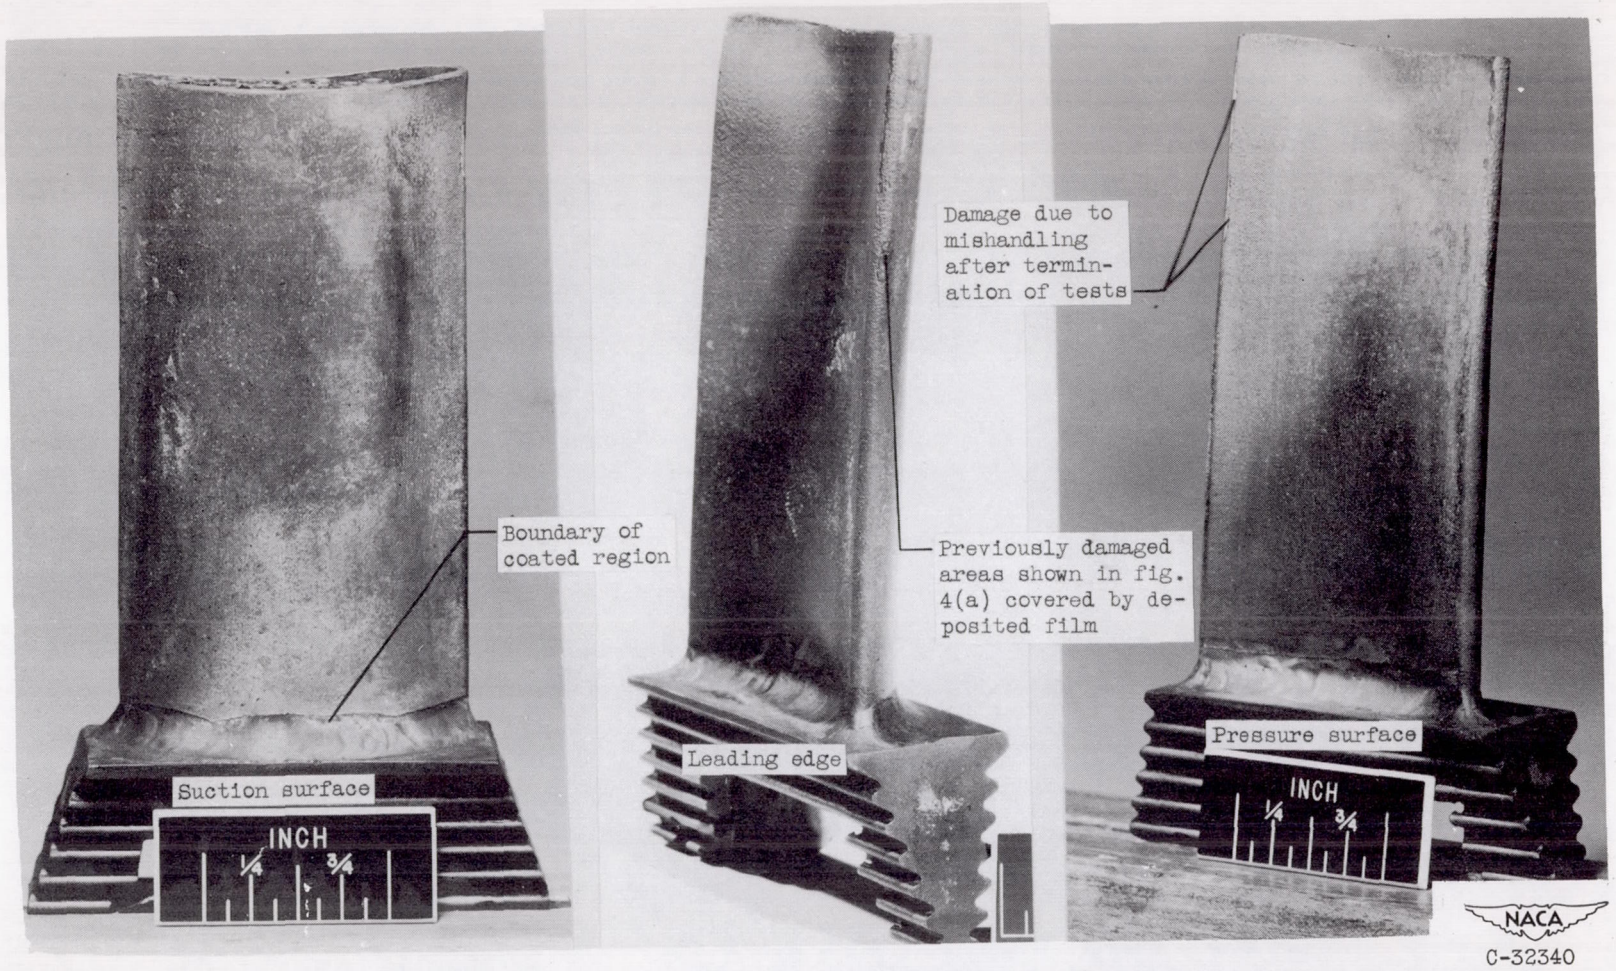
Figure 4. - Ceramic-coated blade 5.

the blade was chipped off and bare metal appeared to be exposed. Operation was continued, however, and after 34.3 hours the blade was again struck by a foreign object and damaged in about the same area as previously. This damage can be seen on the leading edge of the blade in figure 4(a). Several smaller chipped areas were observed in the coating on the forward portion of the suction surface near the blade tip and can also be seen in figure 4(a). Investigation of the coating was continued until the blade was operated for 100 hours at rated test conditions. Figure 4(b) shows the blade upon completion of 100 hours of operation. (The damage to the coating along the trailing edge of the blade which is visible in the view of the pressure surface in fig. 4(b) was caused by mishandling of the blade after completion of the tests.) Microscopic examination of a section through the damaged area at the leading edge indicated that some ceramic still clung to the metal and apparently provided complete corrosion protection since no corrosion could be observed under the microscope. During the investigation of blade 5 no softening or flowing of the coating was observed. No chipping or flaking other than that caused by foreign particles passing through the turbine was observed. Slightly raised markings that became evident on the surface of the coating after heat treating were still visible after 100 hours of running, indicating that the coating had not eroded to any great extent. After 100 hours of operation the coating was in excellent condition except where it had been hit and appeared to provide complete protection for the blade shell even in those areas. Corrosion was observed on the uncoated inner surfaces of the shell and on the cooling-air tubes to depths of 0.003 to 0.005 inch. These observations were made in the immediate vicinity of the leading edge.

(a) Blade 5 after 34.3 hours at rated test conditions with coolant-flow ratio of 0.048. Coating in excellent condition except where damaged by foreign objects striking blade.

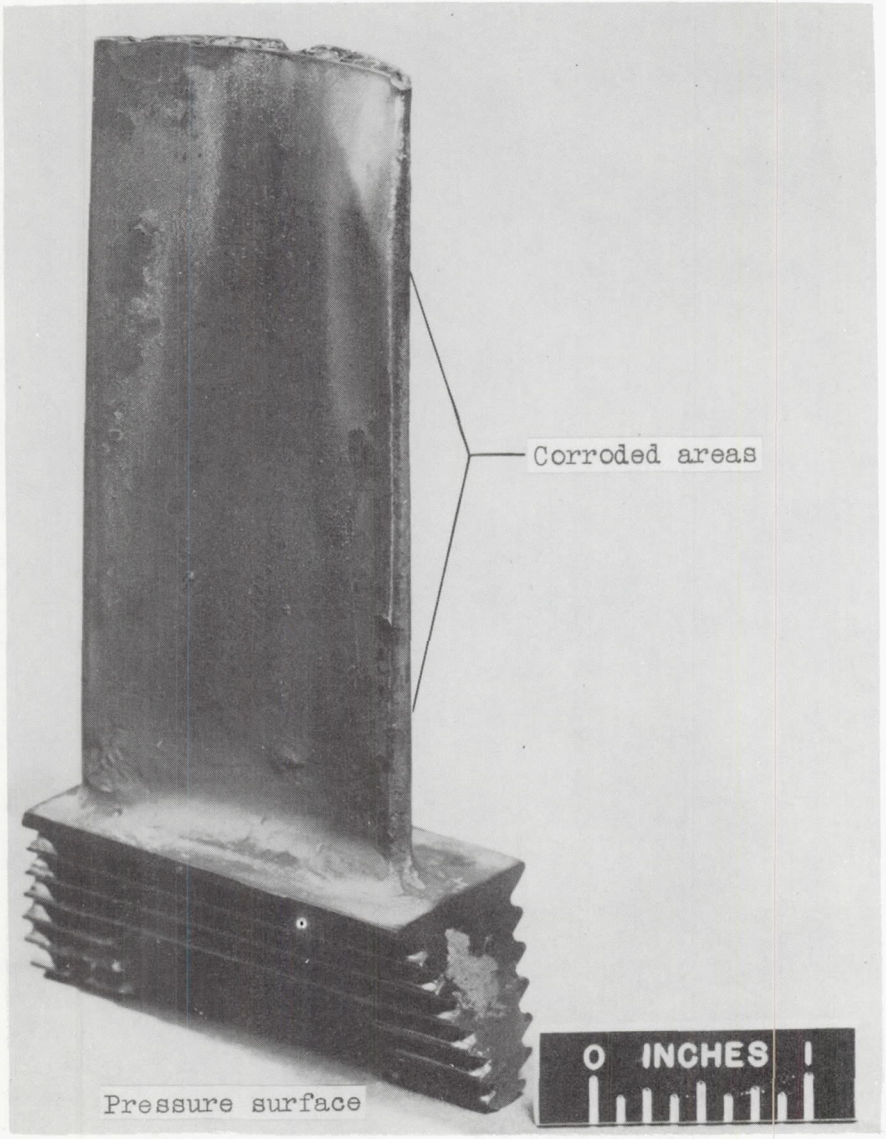
Figure 4. - Concluded. Ceramic-coated blade 5.

(b) Blade 5 after 100 hours at rated test conditions with coolant-flow ratio of 0.048. Coating in excellent condition except where hit by foreign objects.

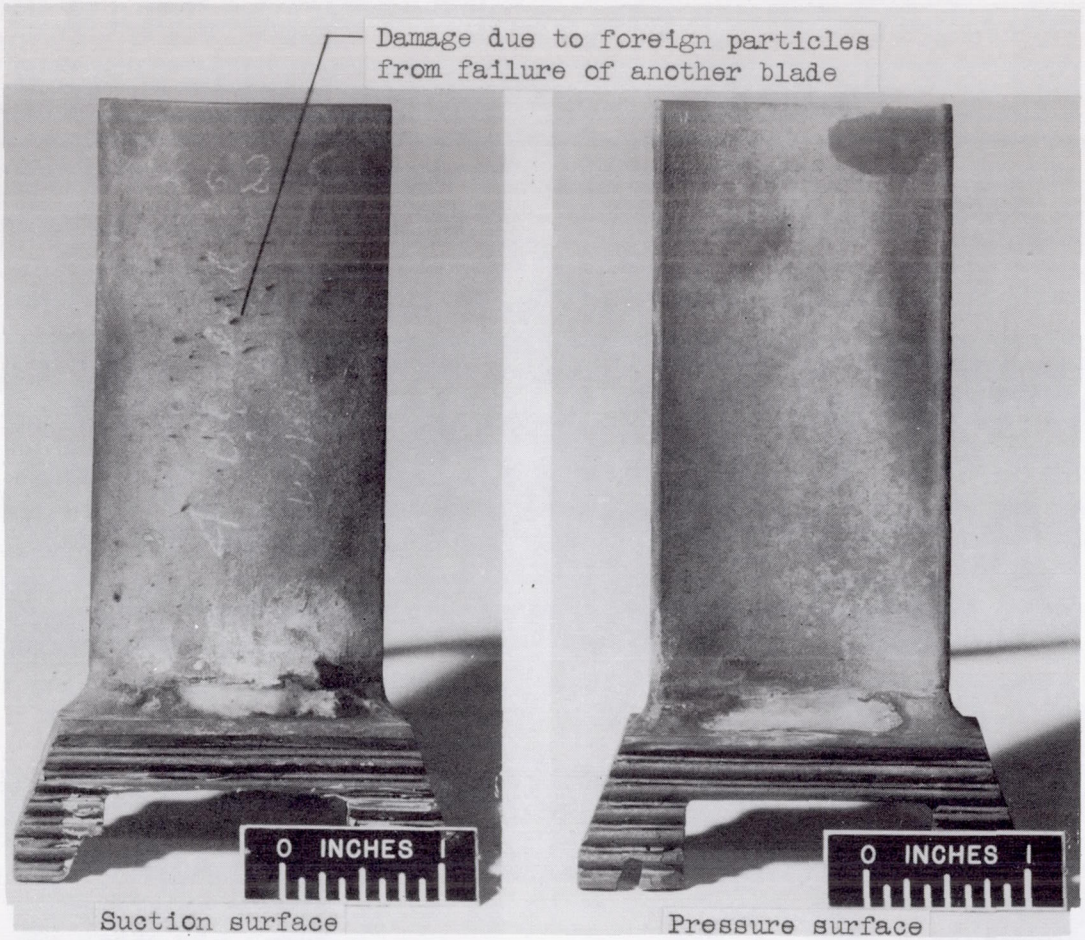
Figure 6. - Nickel-coated blade 20 with Nicrobraz along leading edge. Blade after 100 hours at rated test conditions with coolant-flow ratio of 0.048. Leading edge and midchord region in excellent condition.

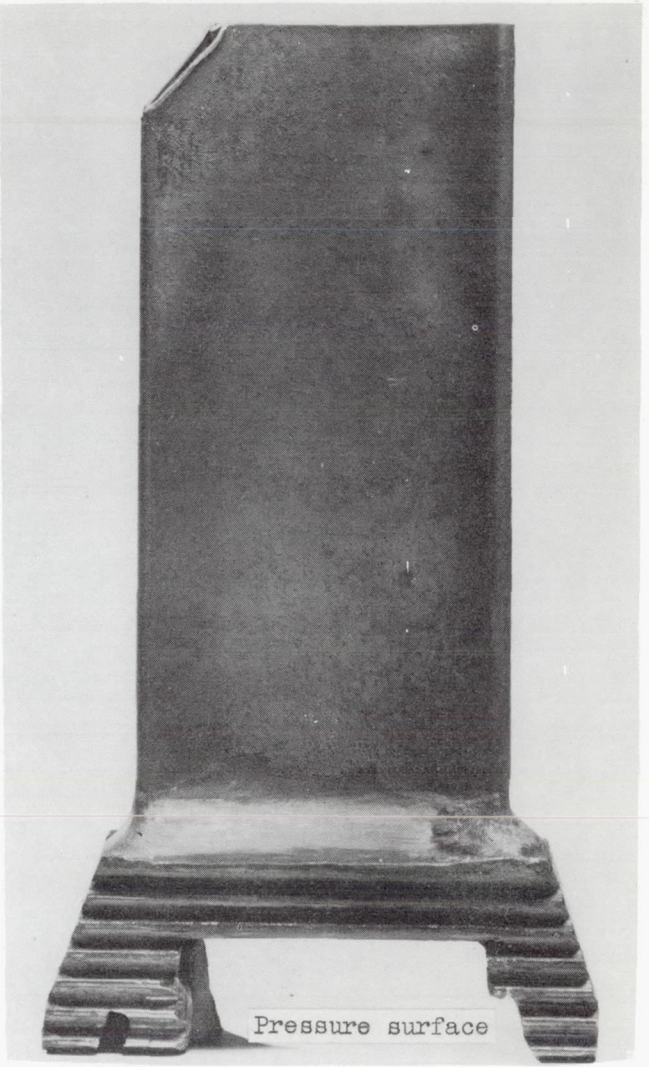
Figure 7. - Aluminized blade 24.

The suction surface of blade 24 was struck by fragments of a failed blade after 50 hours of operation and a number of shallow scratches resulted (see fig. 7(a)). The aluminized layer was sufficiently tough to withstand the impact and no damage was sustained other than the scratches themselves. Upon further running the scratches disappeared and were presumably filled in by iron-aluminum compounds from the adjacent surfaces. The surface of the blade after an additional 50 hours of operation showed no traces of the damage (see fig. 7(b)).

(a) Blade after 50 hours at rated test conditions with coolant-flow ratio of 0.048. Blade surfaces in excellent condition except where hit by foreign particles.

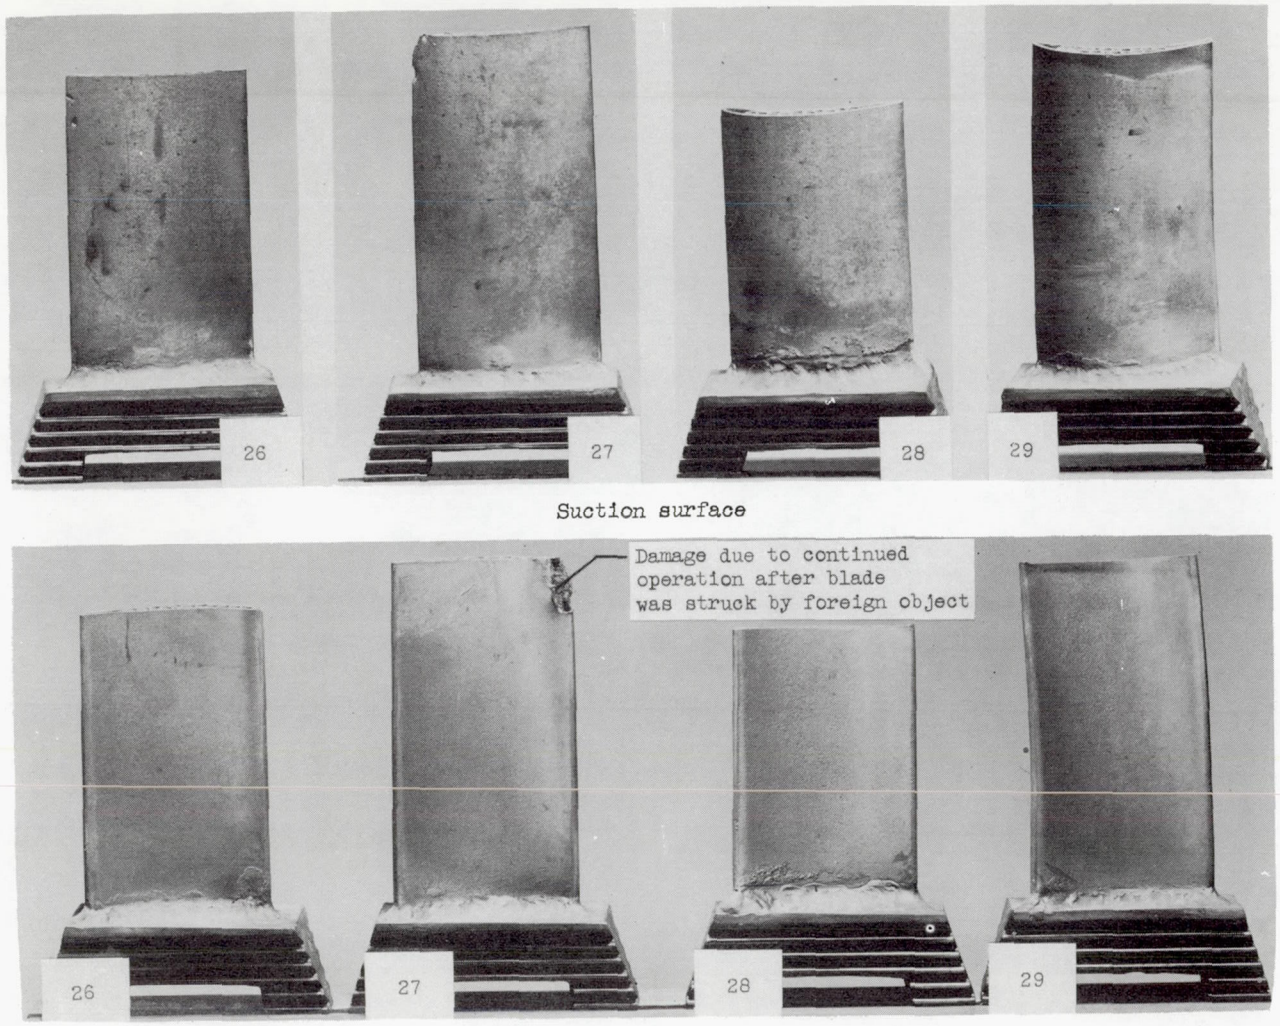
Figure 8. - Aluminized blades 26, 27, 28, and 29.

Figure 8(a) shows the suction surfaces of blades 26, 27, and 28 early in the investigation and of blade 29 prior to operation. Figure 8(b) shows both the pressure and suction surfaces of the blades at the completion of the investigation. Comparison of the suction surfaces shown in figures 8(a) and 8(b) indicates that there was little change in the condition of the coating on the blades, even though the blades of figure 8(b) have about 100 hours more operating time than in figure 8(a). With one exception, the entire surface of each blade including the leading- and trailing-edge regions, which were the first to exhibit failures on the ceramic and nickel coatings, was in excellent condition at the completion of the tests. Surface scratches and abrasions showed no tendency to progress and no corrosion developed in them as the investigation continued. The tip regions of blades 26 and 27 were damaged when struck by fragments of another blade, but the aluminized coatings continued to protect the surrounding areas. No corrosion was evident except on blade 27, where the metal was actually torn and the bare steel was exposed to the action of the gases.

(a) Blades during early stages of endurance running with coolant-flow ratio of 0.03. Time on blades 26 and 27, 23.8 hours; on blade 28, 18.1 hours; on blade 29, no time. Surfaces in excellent condition.

(b) Blades at conclusion of endurance running with a coolant-flow ratio of 0.03. Time on blades 26 and 27, 124.4 hours; on blade 28, 118.7 hours; on blade 29, 100.6 hours. Surfaces in excellent condition.
